No detrimental impact of car manufacturing process and simulation of vehicle in-service conditions on DP1180 hydrogen embrittlement

SUMMARY

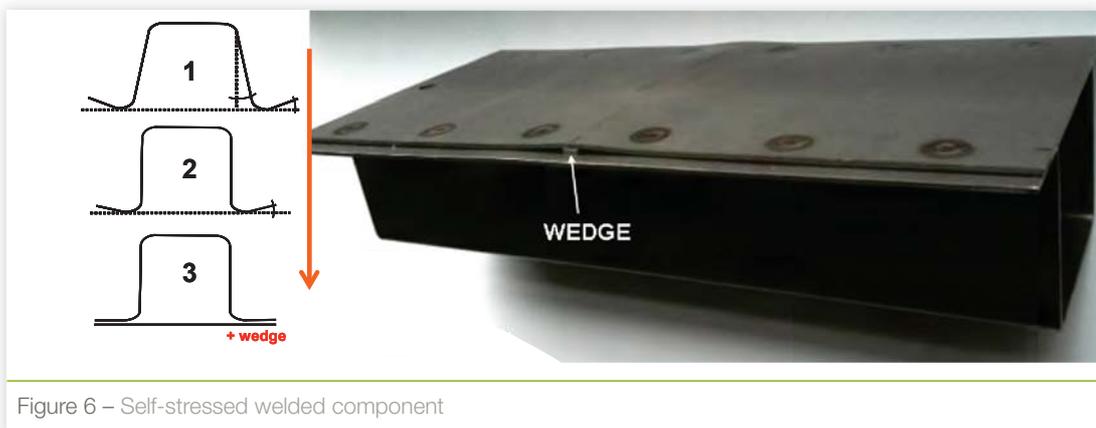
The aim is to quantify hydrogen intake during the carmaker process and assess the delayed fracture risk on a representative component with residual stresses due to forming and welding. This lab component is an over-bent omega shaped rail (to promote residual stresses) closed by a welded plate in order to get the final shape (figure 6). All the elements of the components

Figure 6 – Self-stressed welded component

were basically shear cut. In the middle of the component, a wedge is inserted between the central spot-welds in order to simulate the effect of embossments of a real part (gap effect). It is therefore a self-stressed component (over industrial conditions) with particular high residual stresses on the central spot welds. Finite element simulations have been performed to evaluate local stresses (cut edge and spot weld), cartographies in terms of maximal principal stress are shown in figure 7. As expected, they show high tension areas (red colour) in the spot welds located close to the wedge and in the closure plate which is in contact with the plate. Tested materials were DP1180 bare, DP1180 EG and CP1000 GI. Some of the components were e-coated or pre-treated as this could be considered as the most critical step regarding potential hydrogen pick up following 2 different processes.

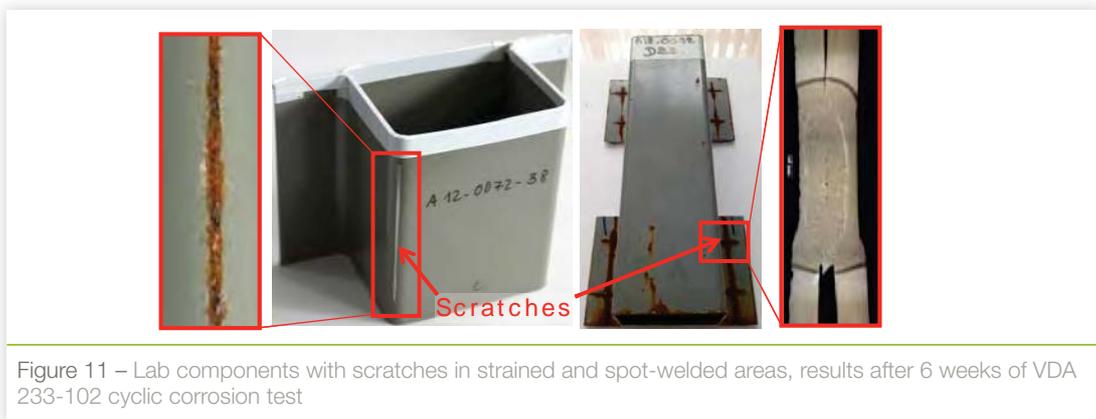
In order to investigate the impact of corrosion in the most strained areas, 6 weeks of VDA 233-102 were performed on lab components whose e-coat in radii and spotwelds were scratched. On all samples, no SCC was observed (figure 11).

Figure 11 – Lab components with scratches in strained and spot-welded areas, results after 6 weeks of VDA 233-102 cyclic corrosion test

- The e-coated and scratched self-stressed lab components do not exhibit any delayed crack after cyclic corrosion tests (VDA 233-102). Hydrogen measurements on samples which were corroded in the same conditions showed, that diffusible hydrogen pick up remains low despite this corrosion attack.
